Manhole Inspection Summary

Manhole # S45KK_048MH

Insp Date: **4/2/08 12:38 PM**

Location Address: **Wolfe St**

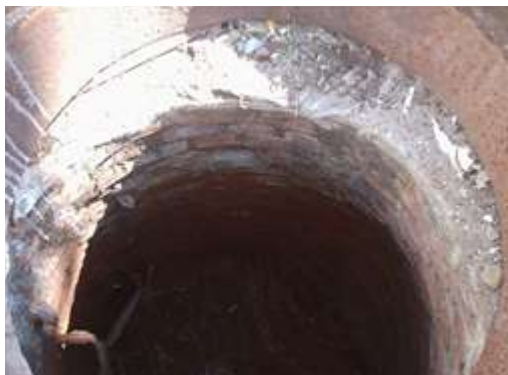
Defect 2

Frame Offset: **6** (in.) Condition: ☐ Sound ☐ Cracked ☒ **Leaks**

Offset

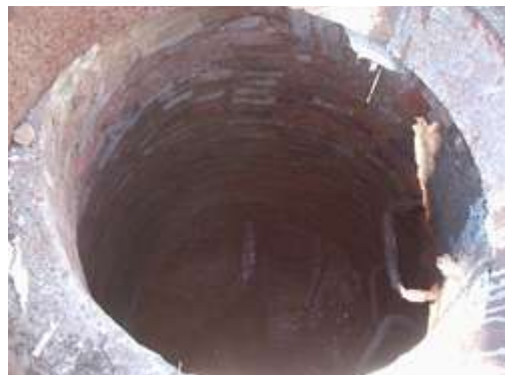
Defect 1

Frame Leaks

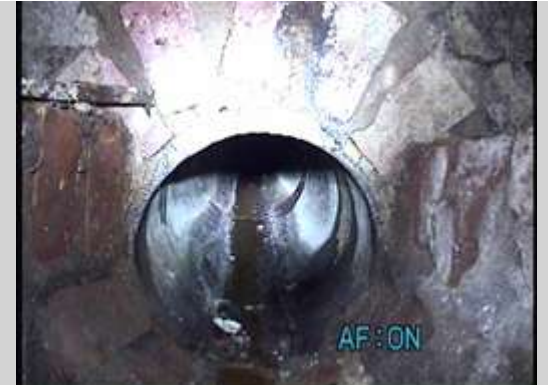
12 O'Clock Outflow

8 in. Circular Gravity Sewer
Pipe Out @ 12 O'Clock

Pipe Height: **8.4** (in.) Rod and Bar (Angled)
Pipe Material: **Clay** ☐ Pipe Lined
Invert Depth: **10.20** (ft.) Flow Characteristics: **Fast**
Deposits: ☒ None ☐ Mud ☐ Sludge ☐ Debris ☐ Grease
Silt Depth: (in.) Deposits Extent:
Infiltration: **None** Pipe Seal Cond: **Sound**

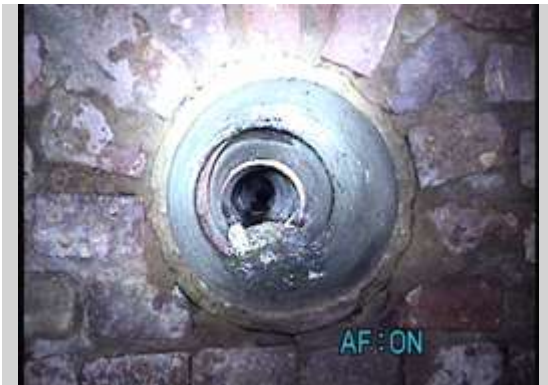
3 O'Clock Inflow

8 in. Circular Gravity Sewer
Pipe In @ 3 O'Clock

Pipe Height: **8.4** (in.) Rod and Bar (Angled)
Pipe Material: **Clay** ☐ Pipe Lined
Invert Depth: **8.40** (ft.) Flow Characteristics: **Fast**
Deposits: ☐ None ☐ Mud ☒ Sludge ☒ Debris ☒ Grease
Silt Depth: **2** (in.) Deposits Extent: **Light**
Infiltration: **None** Pipe Seal Cond: **Sound**

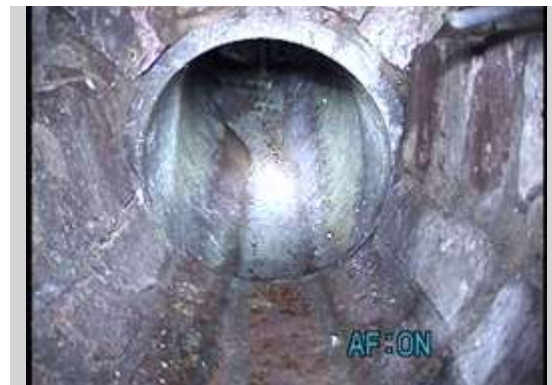
Drop In @ 3 O'Clock

Drop: **Inside** Rod and Bar
Angled: **Yes** Reading: **8.80** (ft.)
Inv Depth: **9.80** (ft.)
Drop Condition: **Open**

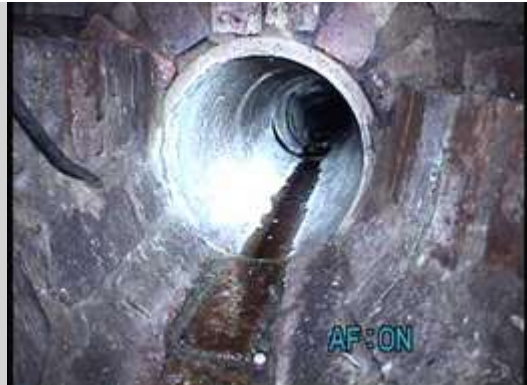
9 O'Clock Inflow

Pipe In @ 9 O'Clock

Invert Depth: **9.90** (ft.) Flow Characteristics: **Slow**

Infiltration: **None** Pipe Seal Cond: **Sound**
